CTAN017: Read Disturb Handling

Covered Products: -503 CF cards, -900S SATA products, -806/808 SD cards, -300 USB products

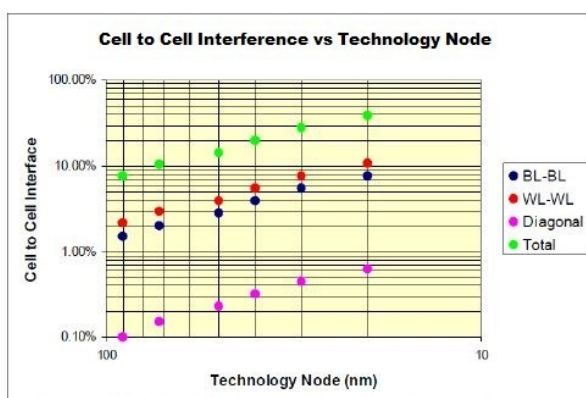
Read disturb errors can also be caused by cross coupling noise from neighbouring cells. These cross coupling noise gets progressively worse as the device geometry shrinks, as illustrated in the following chart:

Chart Source: Prall, K., "Scaling Non-Volatile Memory Below 30 nm" IEEE Non-Volatile Semiconductor Workshop 2007

This type of cross coupling induced errors gets worse over temperature as high temperature accelerates the movement of charge to and from the memory cells.
